# McAllister Technical Services

## BLT86-Series Translators

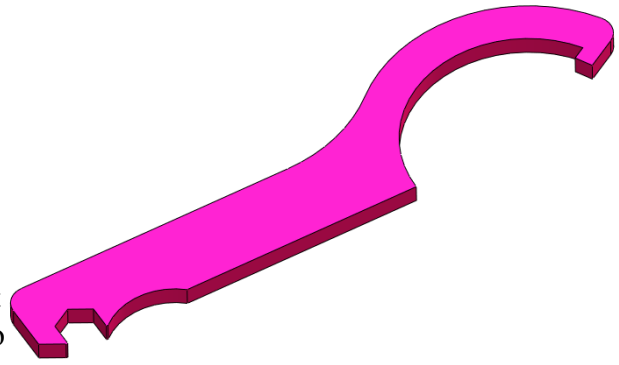
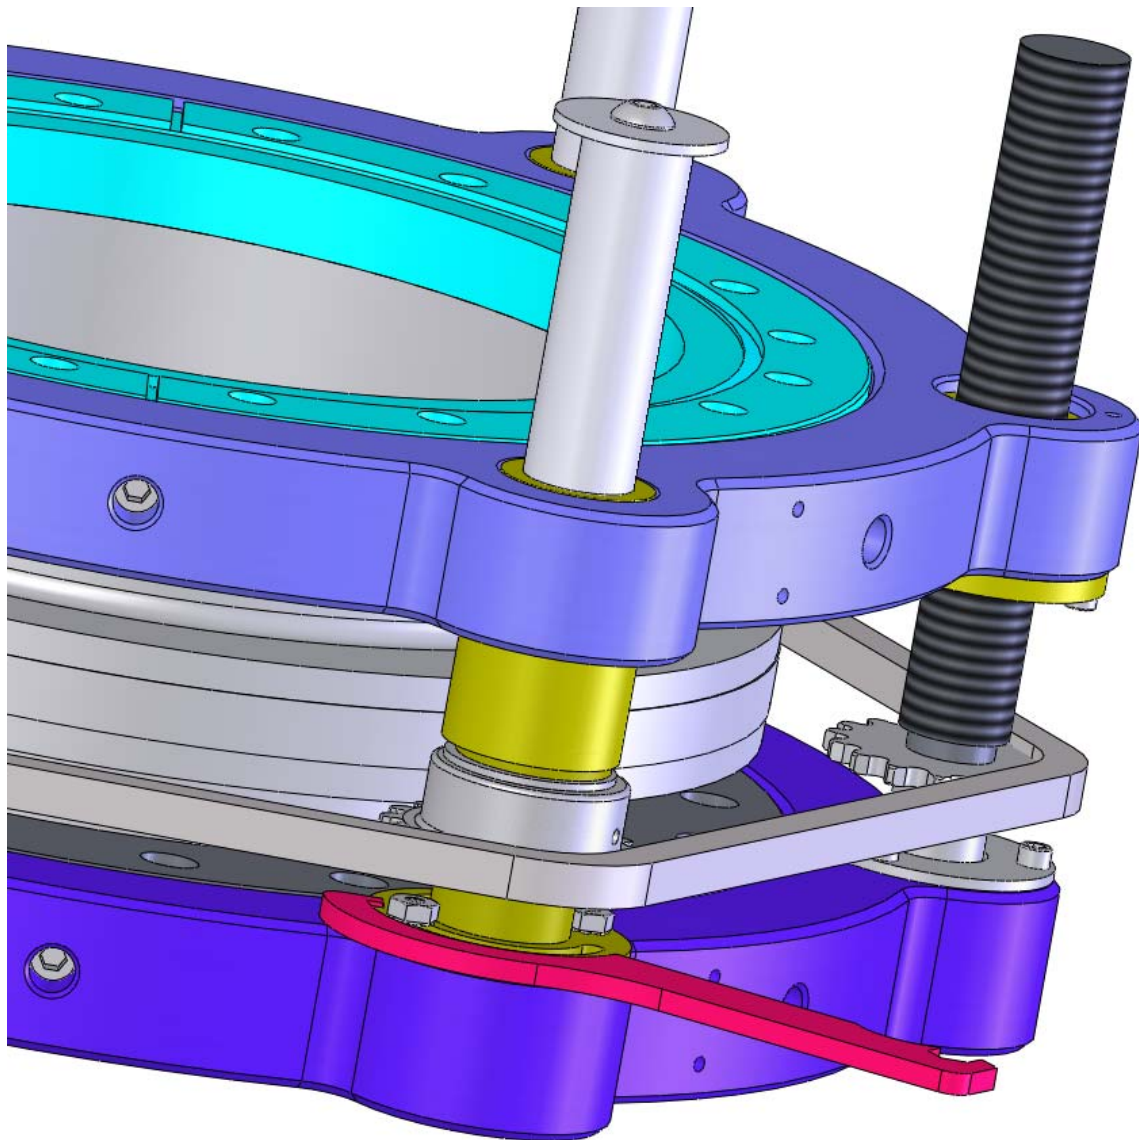
- The chain may stretch with use. This is normal but chain tension is **very important**. When assembled, the maximum lateral play in the chain should be no more than  $\sim 1/2$  chain width ( $\pm 1/4$  each way). Should it become necessary to adjust the tension on the chain, first slightly loosen the two  $1/4$ " nuts beneath the sprocket. Using the supplied wrench (shown at right) wrench, rotate the bronze idler eccentric to achieve the necessary tension. Retighten the two nuts. Repeat as necessary on the remaining eccentrics. It may be necessary to actuate the BLT a few cycles and repeat this process so the chain tension is evenly distributed. **CAUTION:** Over-tightening the chain will place added load on the motor and will cause excessive wear on the bronze eccentrics.

- Occasionally, the flanges may need to be re-aligned to parallel after removing or replacing the chain. Should it become necessary to adjust the alignment of the 2 flanges, first remove the retainer clip and master link from the chain, and then remove the chain from the sprocket. Using dial calipers, or some other measuring instrument, measure the distance between the 2 flanges (or black rings). Adjust the 3 screws individually so that the flanges are parallel to within 0.005" (0.12 mm). Replace the chain and master link.

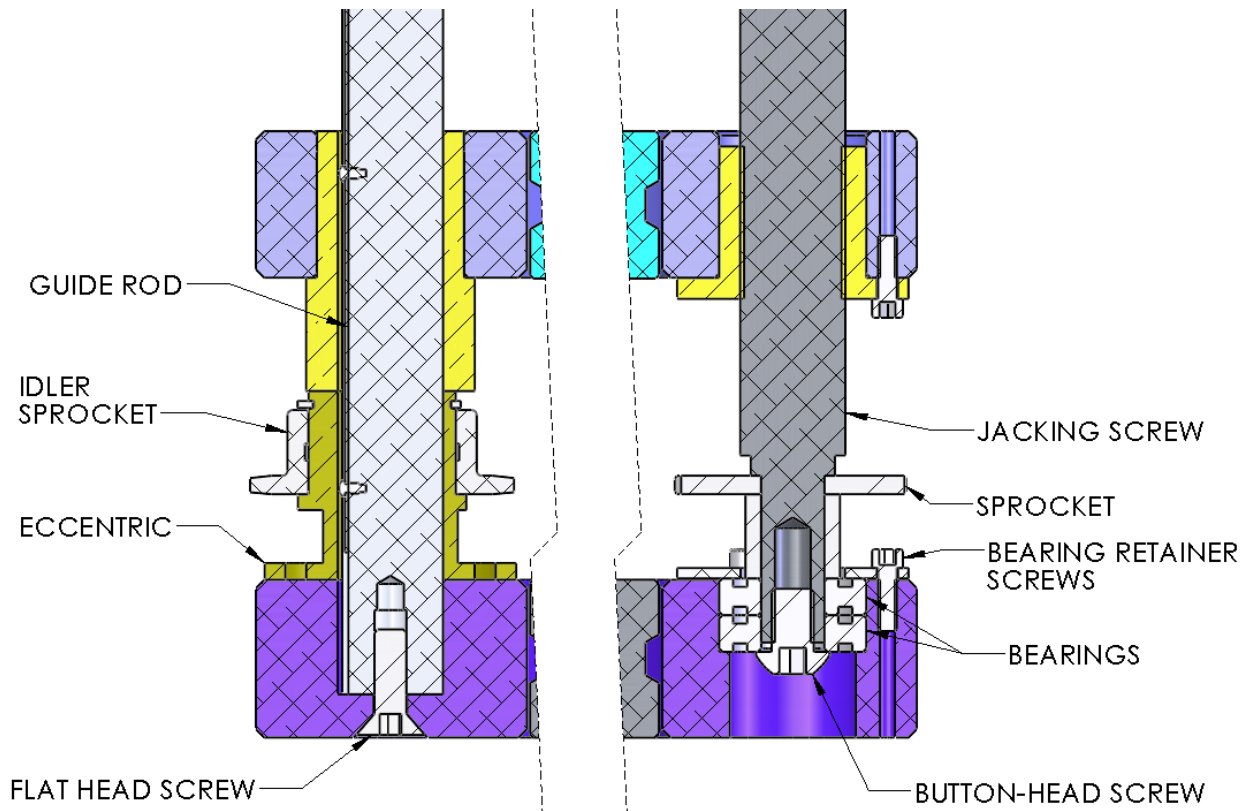
#### Replacing bearings in the BLT86-series

- With the BLT off the vacuum system, remove the screws from underneath the base black ring (from the vacuum-face side of the chamber flange) that go into the jacking screws, and that go into the guide rods. The guide rods should be able to freely slide out of the eccentrics, even if only a little way. Remove the chain, and tap the jacking screws out of the bearings. One way to do this is to put a longer screw (1/4-28, same as for a 2.75" CF) in the thread and tap on that screw. This will free the jacking screws from the black ring. Then remove the bolts from around the circumference of the black ring, and slip the ring off of the flange. With the ring off, remove the screws in the bearing retainer ring and press the bearings out of the black ring using a plug of plastic or a socket, from the backside. Put the new, greased bearings in the holes. Press them in (they are a very light press fit; they won't be very tight), put the bearing retainer rings back on, and repeat the disassembly operations in reverse order. Finally, adjust the flange parallelism and the tension of the chain as detailed above.
